Antifouling Treatment with FuelSolv* FS3954 in a Waste-To-Energy Plant

CASE STUDY | Power

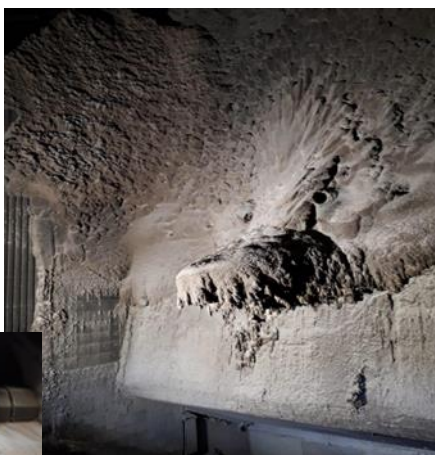
Figure 1

Due to continuous agglomeration and sintering of semi-molten ash particles onto the walls of the combustion chamber (see Figure 1), their progressive thickening, collapsing and falling as blocks on the grates, a waste-to-energy plant, property of Herambiente SpA and located in Italy, was forced to endure unwanted and unplanned outages. Typically, 1-2 unplanned outages per year occurred, with all the related costs in terms of maintenance and production loss.

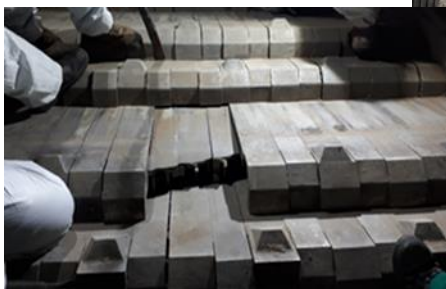
Figure 2

Veolia proposed the use of FuelSolv FS3954 technology, in order to embrittle the deposits, make them more friable and easily removable, eliminating the risk of blocks falling onto the grates with consequent damages and needs for outages (see Figure 2).

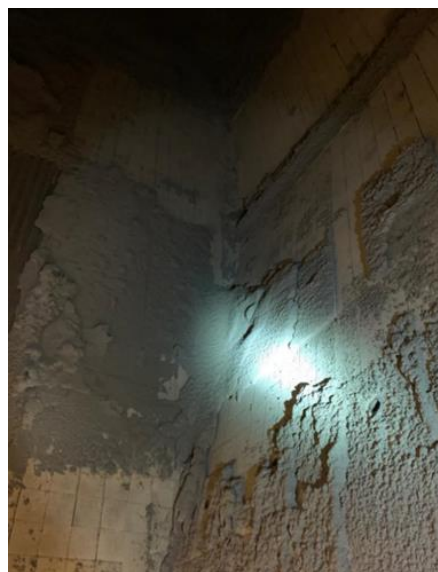
Figure 5

Due to Veolia's FuelSolv FS3954 treatment, the site was able to keep the walls of the combustion chamber much cleaner than in the past (see Figure 5) without the need of intermediate cleaning between one scheduled stop and the other.

After a first cleaning of the combustion chamber, which was required in order to establish a baseline for the conditions of the system, treatment was started and the site personnel could observe a significant change in the behaviour of the deposits. Instead of a compact, hard, collapsing deposit, the new deposits were more friable and no longer prone to build-up of thick and compact clusters.
